TITLE: The Role of Manufacturing Defects in Munition Component Failures

TITLE: New Frontiers in Integrated Diagnostics and Prognostics.  
Proceedings of the 55th Meeting of the Society for Machinery Failure  
Prevention Technology. Virginia Beach, Virginia, April 2 - 5, 2001

## THE ROLE OF MANUFACTURING DEFECTS IN MUNITION COMPONENT FAILURES

Marc Pepi

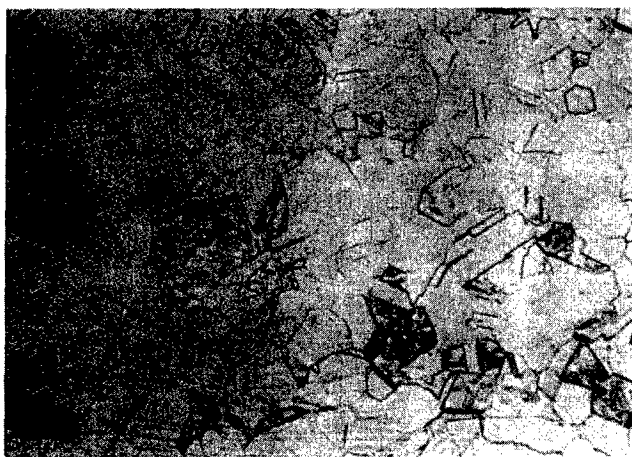
**Results of Investigation:** The chemical composition of the components compared favorably to Type 302 stainless steel, which conformed to the governing requirement (Type 301 or 302). Dimensional inspection revealed that the band was thinner than required. The results of hardness testing were lower than required, and compared more favorably to the material in the annealed condition, rather than the 1/4-hard condition that was required. Metallography results were in agreement with the hardness results, as the grains of the Type 302 stainless steel were equiaxed, rather than flattened, or “pancaked” (see Figure 1). Tensile testing confirmed that the component was annealed, as the results did not compare favorably with those for the 1/4-hard condition.

**Effect of Manufacturing Defect on Performance:** The retaining band was able to unwrap itself from the clamp tightener because it was thinner than required, and softer (less stiff) than intended.

**Figure 1** Micrograph showing the equiaxed grains of the Type 302 stainless steel, typical of the annealed condition. Mag. 400x.

**Outcome:** The NAWC is going to scrap the retaining band kits fabricated by the manufacturer of the suspect kits, and procure new components. They will oversee the manufacturers procedures and perform first article testing to ensure this type of situation does not occur again.

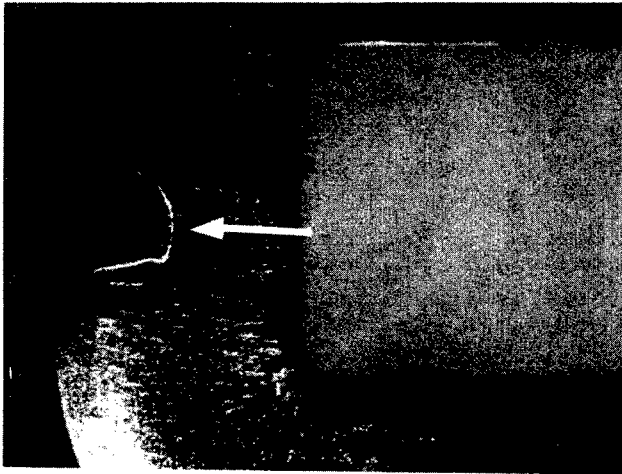
**Results of Investigation:** Visual examination revealed a blackened region at the crack origin of each failure. In addition, a forming lap was found on the external bail surface of one of the failed lugs. Material sectioned from the failed lugs and subjected to chemical analysis conformed to governing specification. Metallographic examination adjacent to the blackened regions at the crack initiation sites showed slight carburization upon etching. This indicated that the regions were exposed to the high temperatures associated with the heat treatment. The hardness of the component was acceptable. Electron microscopy of the blackened surface revealed a featureless condition associated with oxide formation. It was concluded that the lugs failed due to overload conditions, as determined by the predominantly ductile dimpled fracture surface. Energy dispersive spectroscopy of the blackened regions revealed evidence of a corrosion product or heat treat scale.

**Effect of Manufacturing Defects on Performance:** A lap is caused by the folding over of metal into the surface of the part during forming [1], while a seam is a discontinuity in a part caused by an incomplete joining of material during forming [2]. As shown in proof testing, the lugs were very sensitive to these surface anomalies. It was fortunate that defective lugs were revealed as a result of this proof testing (which is performed on a sampling basis), rather than in service.

**Figure 2** Blacklight macrograph showing typical lap defect within the bail region. Mag. 3x

**Outcome:** An extensive lug screening process was undertaken, whereby the parts that were previously magnetic particle inspected were subjected to an additional inspection consisting of a central conductor shot and a head-shot. The handling of the lugs subsequent to inspection was also improved, in an effort to reduce the masking of defective parts. Thousands of lugs were scrapped as a result of this re-inspection, and the warranty clause was invoked by the NAWC.

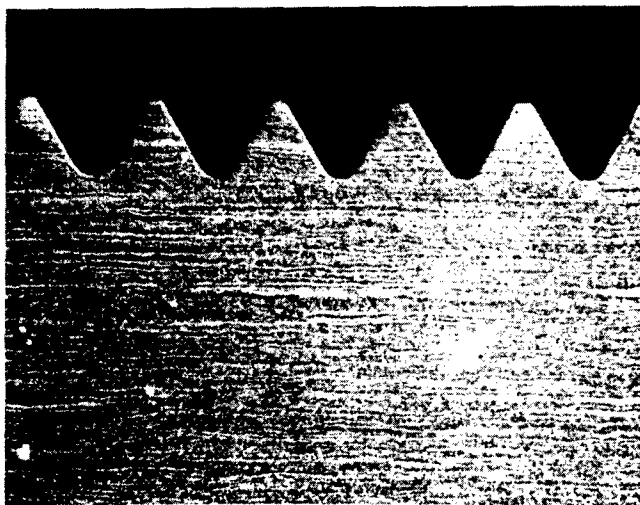
**Results of Investigation:** Metallography and hardness testing revealed that the bolts were inadvertently carburized, which was not in conformance with the governing requirements. Additionally, macroetching revealed that the parts were machined from stock (rather than forged) and the threads were cut (rather than rolled). Figure 3 shows the etched grain flow within the threads. The rolling process would have produced a grain flow that followed the contour of the threads, however, the grain flow in Figure 3 does not follow the contour. It was determined that hydrogen-assisted stress corrosion cracking (SCC) was the probable cause of failure in both bolts. Hydrogen charging resulted from the surface corrosion. Contributing factors to SCC included surface carburization and the unacceptable grain flow pattern. Carburization resulted in a much harder (less tough) surface, while the stress distribution within the bolt head was adversely affected by the improper grain flow.

**Effect of Manufacturing Defects on Performance:** The forging process results in a grain flow that follows the contour of the part, and offers three distinct advantages compared to a part that was machined; enhanced directional strength, structural integrity and dynamic properties [3]. By refining the grain structure and developing optimum grain flow, forging promotes desirable directional properties such as tensile strength and ductility, and dynamic

properties such as impact toughness, fracture toughness and fatigue strength. With respect to structural integrity, forged parts are generally free from voids and porosity. All of these properties for the bolts under investigation were compromised as a result of the parts being machined rather than forged. The same advantages apply to threads that are rolled rather than cut. Carburization raises the surface hardness of the part, and is usually beneficial with respect to surface wear and fatigue resistance. However, the increased surface hardness made these components more susceptible to hydrogen attack.

**Figure 3** Macrograph showing the grain flow within the threads of the LAU-7 bolt. Note the flow does not follow the contour of the threads, indicating the threads were cut (machined) rather than rolled. Mag. 12.5x.

**Outcome:** As mentioned, ARL offered a short-term recommendation concerning which bolts to continue using, and a long-term recommendation to consider changing the bolt to a lower strength (higher ductility, fracture toughness) material.

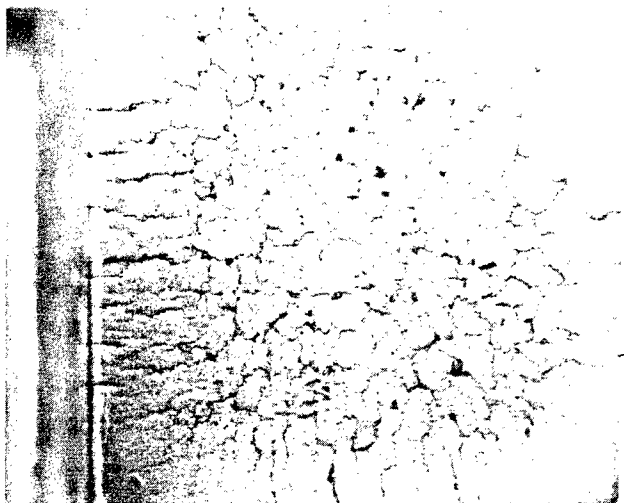
**Results of Investigation:** Visual examination revealed the presence of "heat checks" (Figure 5) on the surface of the tailcones, while radiography showed indications of foreign material (both more and less dense than the casting material), gas holes, and shrinkage defects. Tensile testing showed that the specimens fabricated from the components did not meet the required mechanical properties for this alloy. In some cases, the tensile failures initiated at large inclusions.

**Effect of Manufacturing Defects on Performance:** Heat checks are most often located on surfaces that correspond to areas in the die which are subject to high thermal stresses or where the liquid metal flows at high speeds causing erosion of the mold or die cavity [4]. These defects can also be caused by extended mold usage or die wear, and are open to the surface, resulting in decreased structural integrity. Gas holes (porosity) are generally formed by an excessive amount of gas in the metal bath, which is released during solidification. This defect reduces the cross sectional area of the component. Shrinkage typically occurs in the last areas to solidify, or areas in contact with gates. This defect reduces the cross sectional area of the component to a greater extent than porosity. In

**Figure 4** Macrograph showing the heat checks noted on the tailcone sections. Mag. 1.8x.

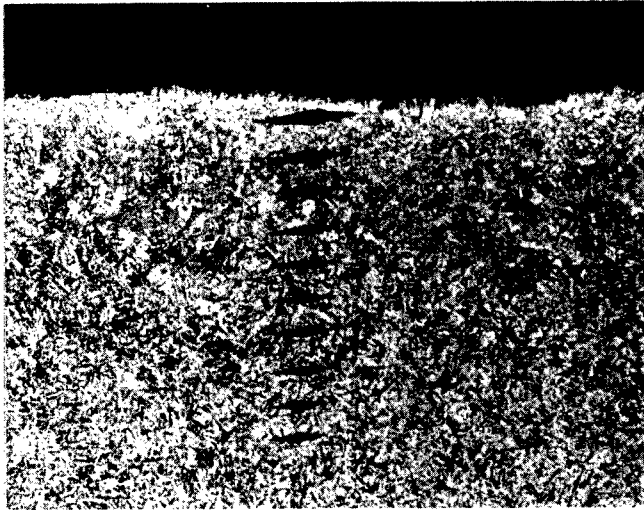
**Results of Investigation:** Visual examination of the individual locking block revealed corrosion and a rougher than nominal surface finish. Metallography revealed a *complete* layer of decarburization along the periphery of the component, which was prohibited according to the governing specification. The depth of decarburization was greater than specified (0.006 vs. 0.003-inch). Hardness testing showed that the entire component (not just the area above the bail, as specified) was hardened to 50 – 55 HRC, not 38 – 43. Hardness testing also showed a loss of surface hardness due to the presence of the decarburization (~20 HRC at the surface, as opposed to 50 – 55 HRC elsewhere). Figure 6 shows a Knoop microhardness profile through the decarburized layer. Note the larger surface readings corresponding to a lower hardness. In addition, the unused top and bottom bolt shafts were not nitrided, as confirmed through metallography and microhardness testing. These components also had a higher than specified silicon content by almost double. Finally, both of the spiral spring pins failed to achieve the 3,900-pound double shear load. One of these pins contained carbon approximately 10 times the requirement, which could have attributed to the poor double shear results.

**Effect of Manufacturing Defects on Performance:** With respect to chemistry, the silicon content of maraging steels should not exceed the maximum limit, since the notch tensile strength [7], as well as the toughness [8] have been shown to be detrimentally affected. Concerning heat treatment, decarburization is a loss of carbon from the surface of a hardened steel part usually caused by an excessively high dew point or low carbon potential during the diffusion portion of a carbide-diffuse cycle, or of prolonged reheating in moist air or other decarburizing gas [9]. A complete decarburized layer consists of ferrite, which transitions to a layer of ferrite plus a low-carbon martensite towards the core of the component, followed by the normal tempered martensitic structure. The presence of decarburization acts to lower the surface hardness of a component, as was shown during the ARL analysis. Decarburization also affects the wear and fatigue resistance of a component. Finally, the effect of a lack of nitriding on a maraged steel component was shown by the in-service fatigue failure. Nitriding of maraging steels is performed to provide resistance to wear and fatigue [10], and should not have been neglected given the application.

**Figure 6** Microstructure of a locking block that contained decarburization. Note the softer surface indicated by the larger Knoop microhardness readings. Mag. 200x.
